Subject: 2017 Algae Mats on Hagerman Lake

May 18, 2017

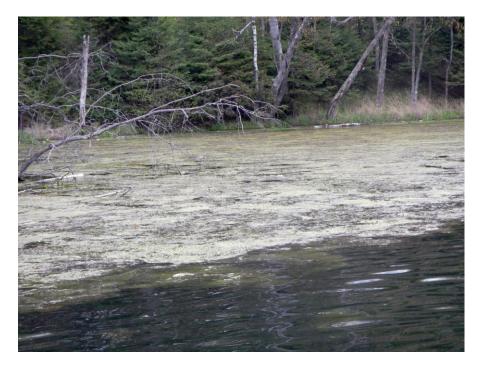
Exhibit 1.

On the evening of May 16th, White Water Aquatic Biologist Angie Stine and a co-worker visited Hagerman Lake. Using a boat they searched bays and found algae mats that had surfaced and accumulated on the windward edge of the bays. Photos were taken and displayed below as Exhibits 1, 2, and 3. Location: N46.23499 W088.45473.

Angie Stine suspected that the mats were comprised of filamentous algae that had surfaced because of spring conditions and accumulated due to wind activity. To confirm this observation, Stine contacted algae expert, Gina Laliberte (Wisconsin DNR) and provided photos.

Aquatic algae are a natural part of lakes ecology. Algae are important food source for zooplankton which provides food for fish. Algae mats provide cover for small animals such as insects, snails, and scuds. Despite these ecological benefits, large algae blooms can cause aesthetic or recreational impacts. These blooms can be minimized by limiting the flow of nutrients into the lake. Hagerman Lake stewards can help reduce the accumulation of phosphorous in the lake by:

- Reducing or eliminating fertilizer use on lawns;
- Maintaining septic systems properly;
- Redirecting nutrient-rich runoff away from the lake; and
- Maintaining a vegetative buffer strip along the shoreline to filter runoff.

A conductivity survey could be conducted along the shoreline of Hagerman Lake at the end of the summer to determine if any particular area of the lake shore may be contributing more nutrients into the lake. Lake conductivity studies are sometimes conducted to determine if there are faulty septic systems or other pollution sources present that could be delivering excess nutrients into a lake. Low values of conductivity are characteristic of high-quality, oligotrophic (low nutrient) lake waters.
