Hagerman Lake (Iron County, Michigan)

Aquatic Invasive Species Report

Date: 2019

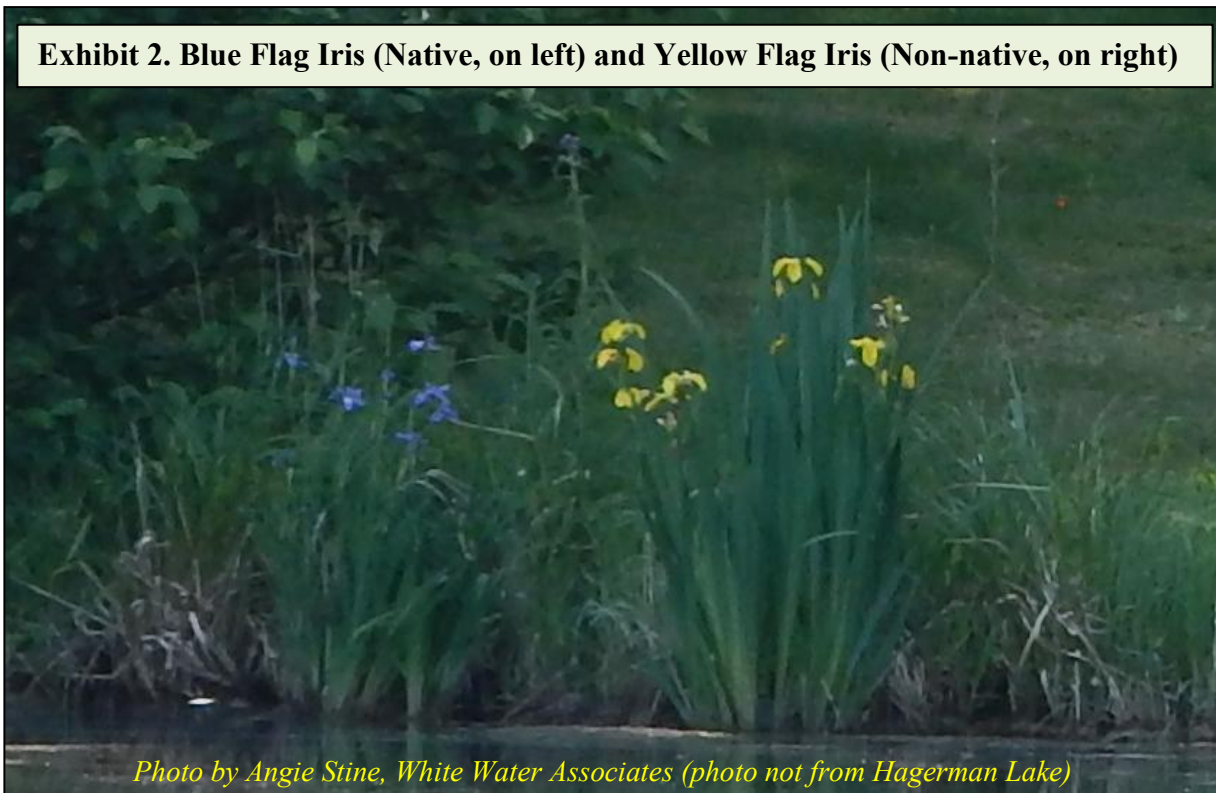
The yellow iris (Exhibit 2) (*Iris pseudacorus*) is a perennial aquatic plant native to Europe, western Asia and North Africa. It was first introduced to North America in the 1800s as an ornamental plant. Over time, the plant has spread to many wetlands and proliferated to the detriment of native plants and animals. Yellow iris is present in numerous Michigan and Wisconsin lake margins. The yellow iris can reduce habitat needed by fish and waterfowl (Thomas 1980). Yellow iris is suspected on Hagerman Lake, but as yet has not been verified by a survey during the flowering season. A future survey, when the yellow iris is in bloom, would be beneficial to determine what strategies could be used to help control this plant.

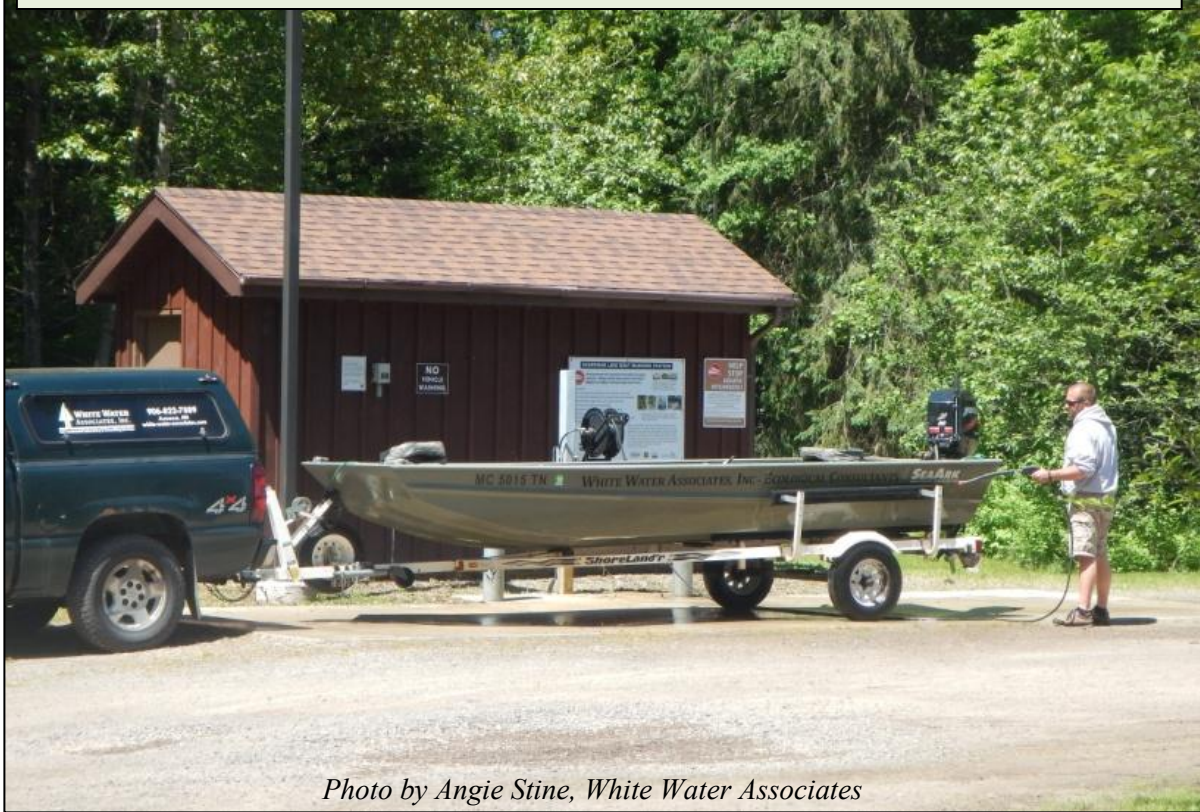
Exhibit 4. White Water Associates boat at the Hagerman Lake boat wash station.

Clean Boats Clean Waters is a program to educate stakeholders on the importance of transporting aquatic invasive species. Hagerman Lake is fortunate enough to have a permanent boat wash with high pressure water to clean boats (Exhibit 4). The use of this boat wash is imperative to protecting Hagerman Lake from introduction of aquatic invasive species. In order to educate users of Hagerman Lake about lake stewardship and use of the boat wash station, Angie Stine (White Water Associates aquatic biologist) gave a presentation at the boat wash station and boat landing in 2016. Stine also presented on aquatic invasive species to the HLPOA annual meeting in August of 2016. There is a link on the HLPOA website to this PowerPoint document (www.hagermanlake.org). There is also a brochure on the website describing what HLPOA is and about aquatic invasive species.
