Hagerman Lake (Iron County, Michigan) Aquatic Invasive Species Monitoring Report

Date: November 2024

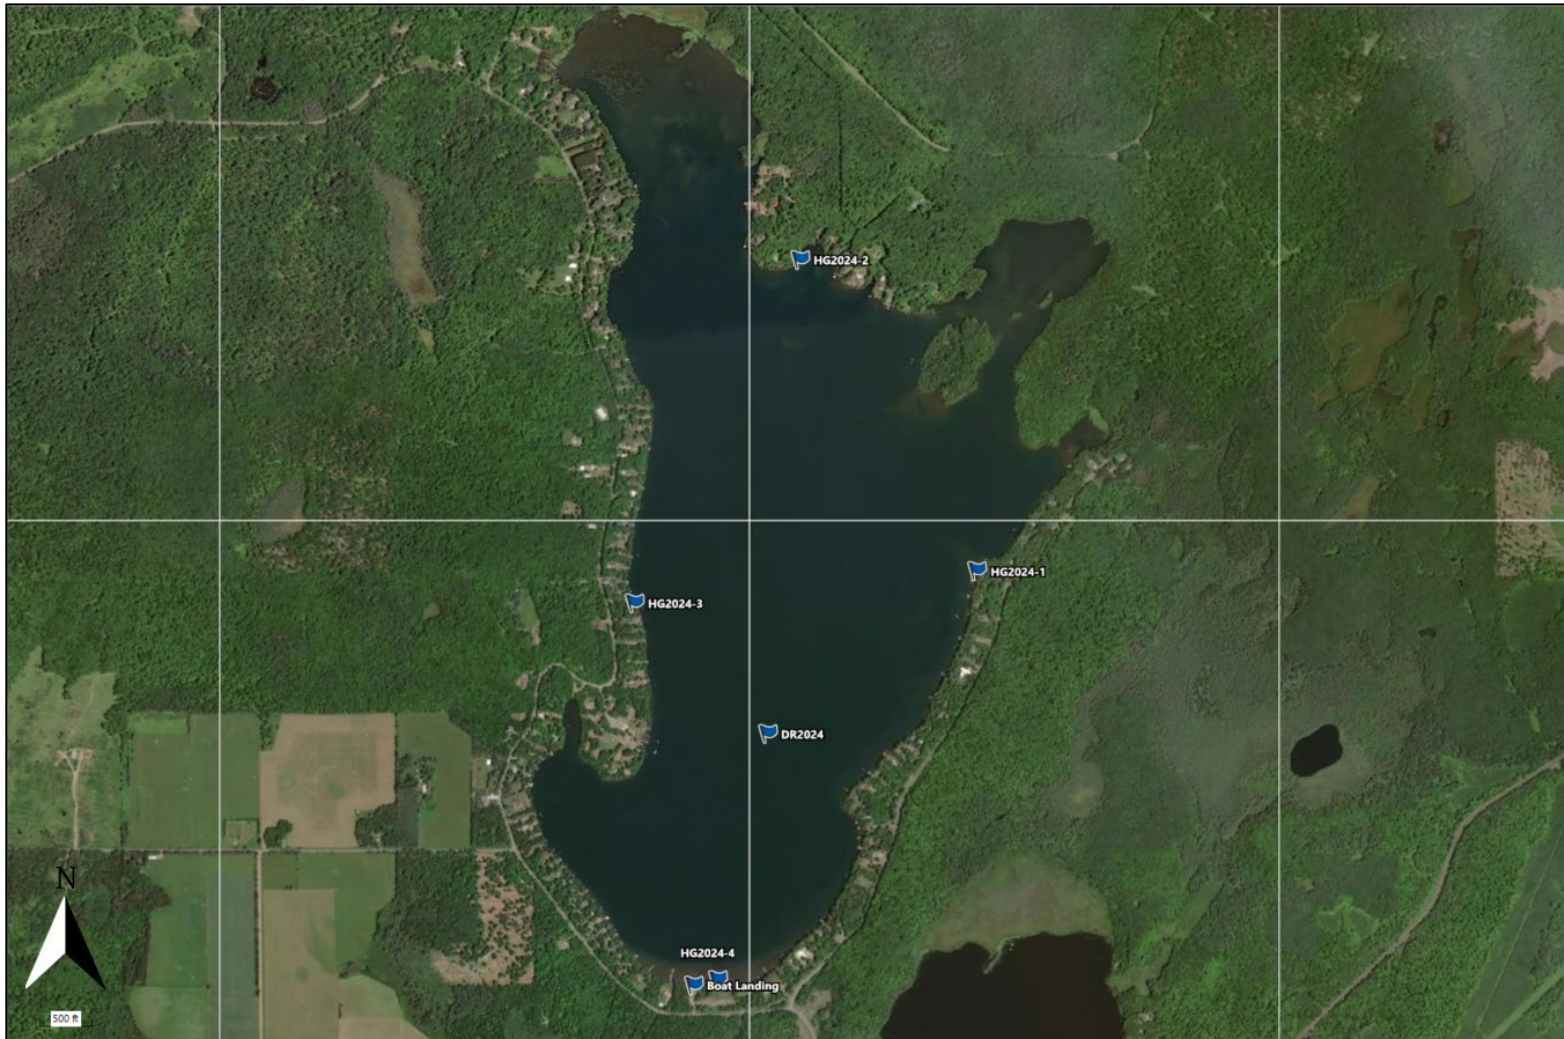
Map 1. Hagerman Lake target search site (HG2024-#), dredge (DR2024) locations.

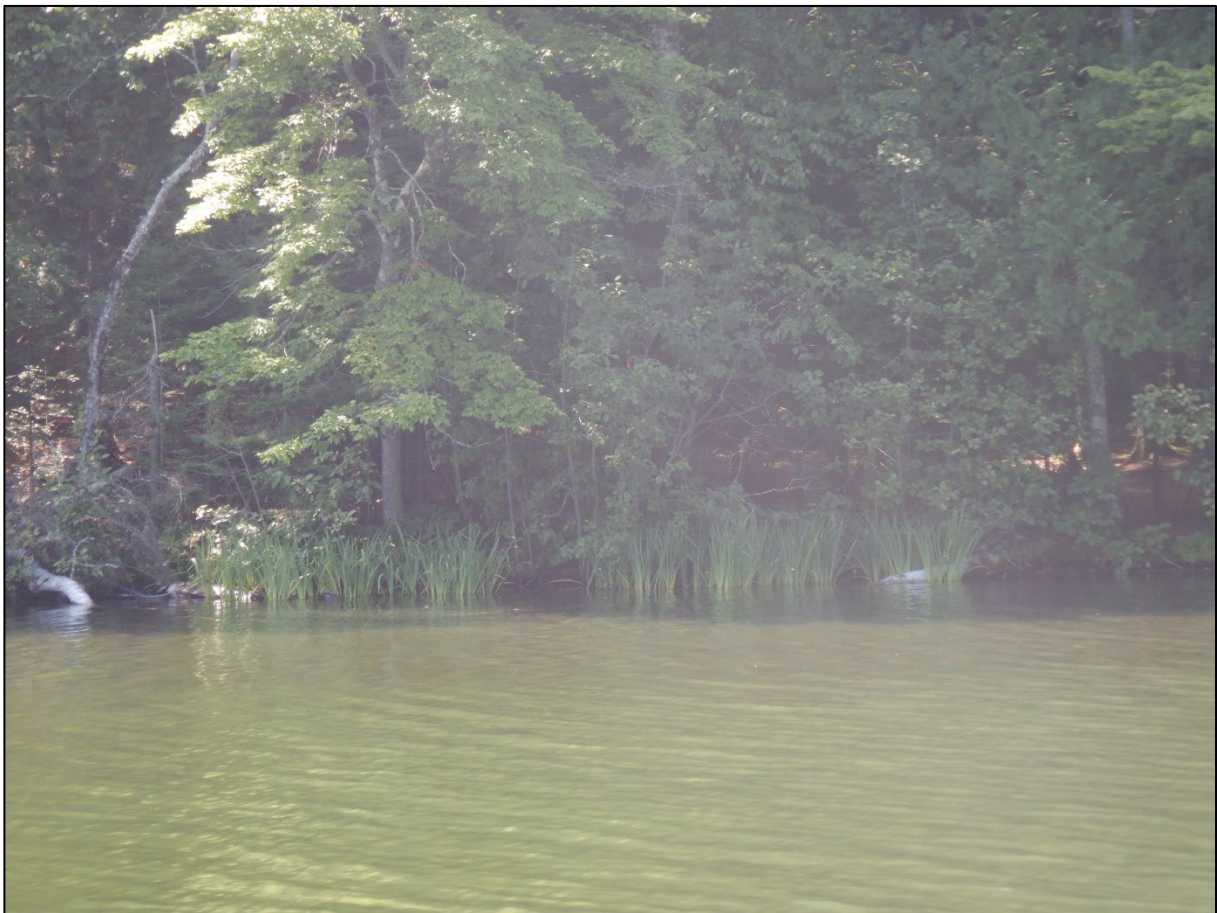
1. **Yellow iris.** At the time of the 2024 survey, the yellow iris plant was not in flower, but plants observed along the shore of the lake were likely of this species (Photo 1). An early season survey could be beneficial to focus on locating the invasive species. We recommend that to dug up yellow iris and replace them with the native blue flag iris (*Iris versicolor*). These would be available from nurseries.

Photo 1. Yellow iris in Hagerman Lake shoreline (Photo taken August 2024).

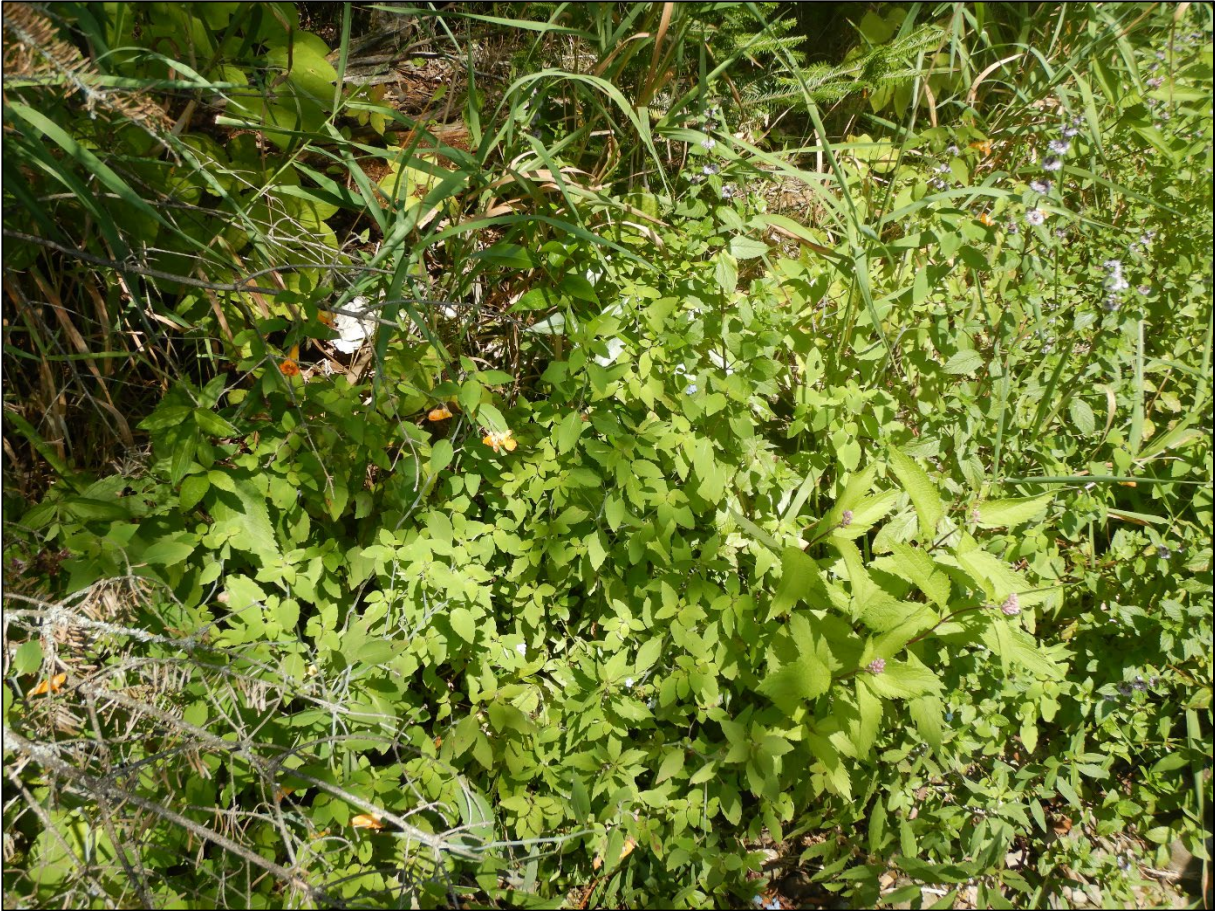
2. *Aquatic forget-me-not*. This invasive species can quickly crowd plant species and is able to form large monocultures (Photo 2). This, in turn, affects community compositions by reducing the number of native herbs (WIDNR, 2024). Aquatic forget-me-not is difficult to control due to its mechanisms for spreading (WIDNR, 2024).

Photo 2. Aquatic forget-me-not in Hagerman Lake shoreline (Photo taken August 2024).

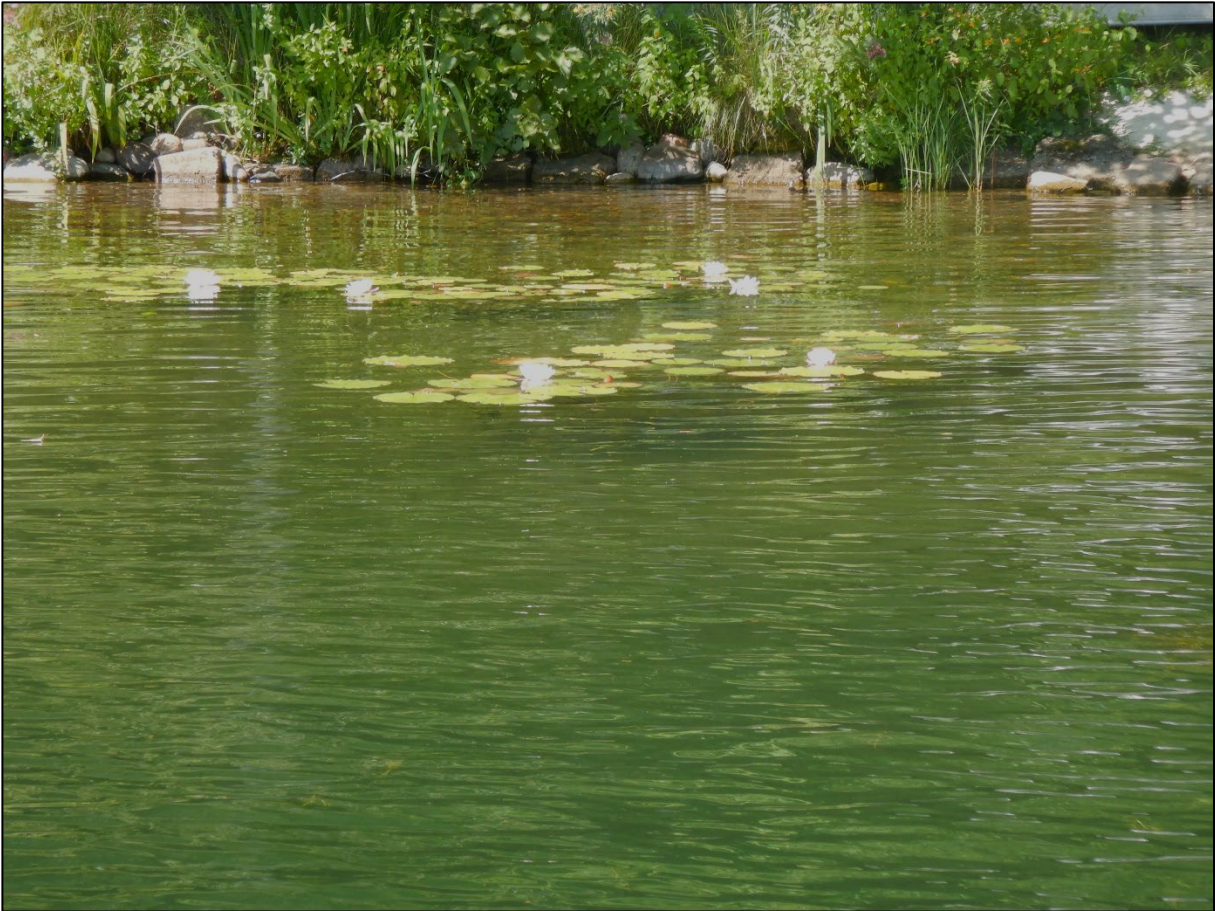
3. ***Pink water lily***. The plant is still present at the location (46.05385, -88.78725) and did not seem to have spread (Photo 3).

Photo 3. Pink water lily in Hagerman Lake shoreline (Photo taken August 2024).

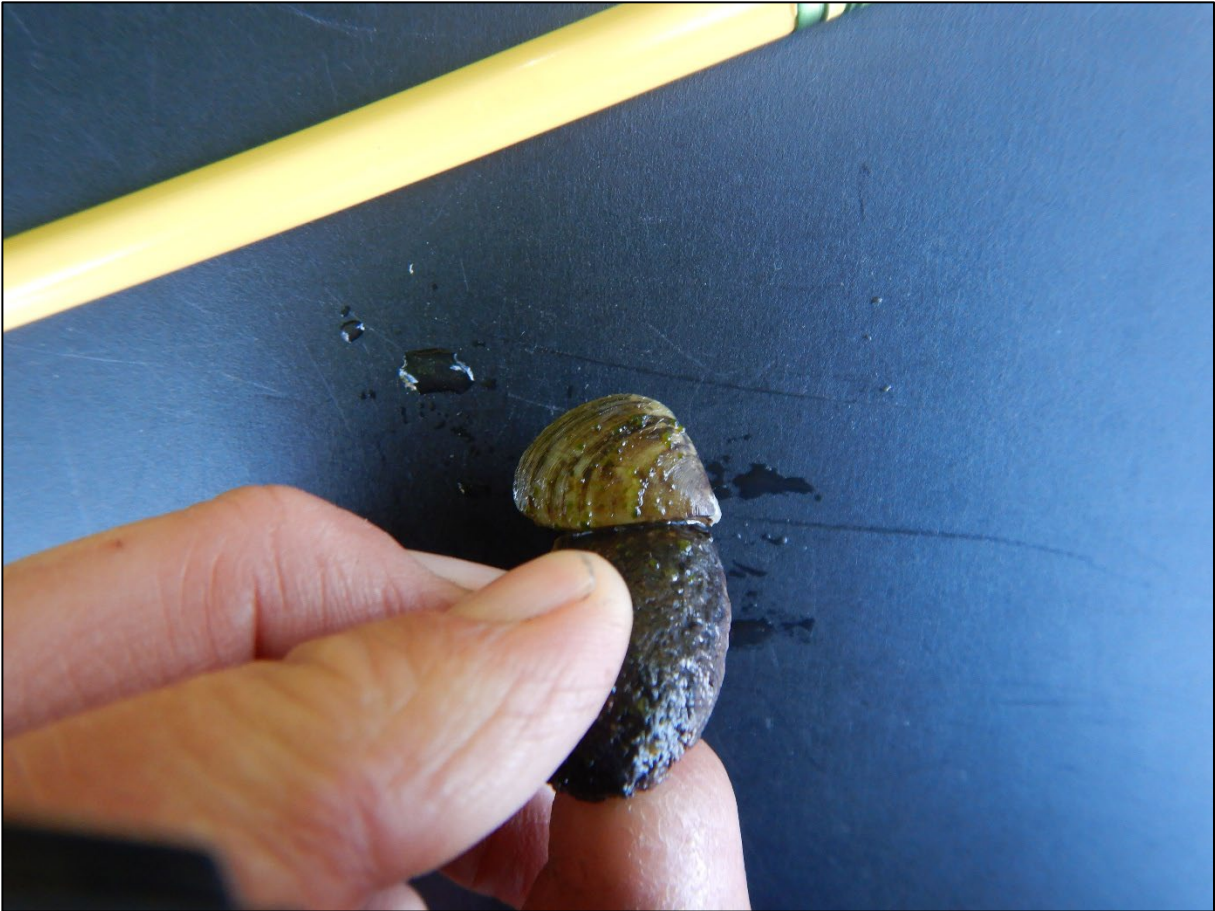
4. *Zebra mussel* (Photo 4). Live and dead specimen of zebra mussels were found in low density at one of the target search sites and at the boat landing (Table 1).

Photo 4. Live zebra mussel specimen found in Hagerman Lake (Photo taken August 2024).

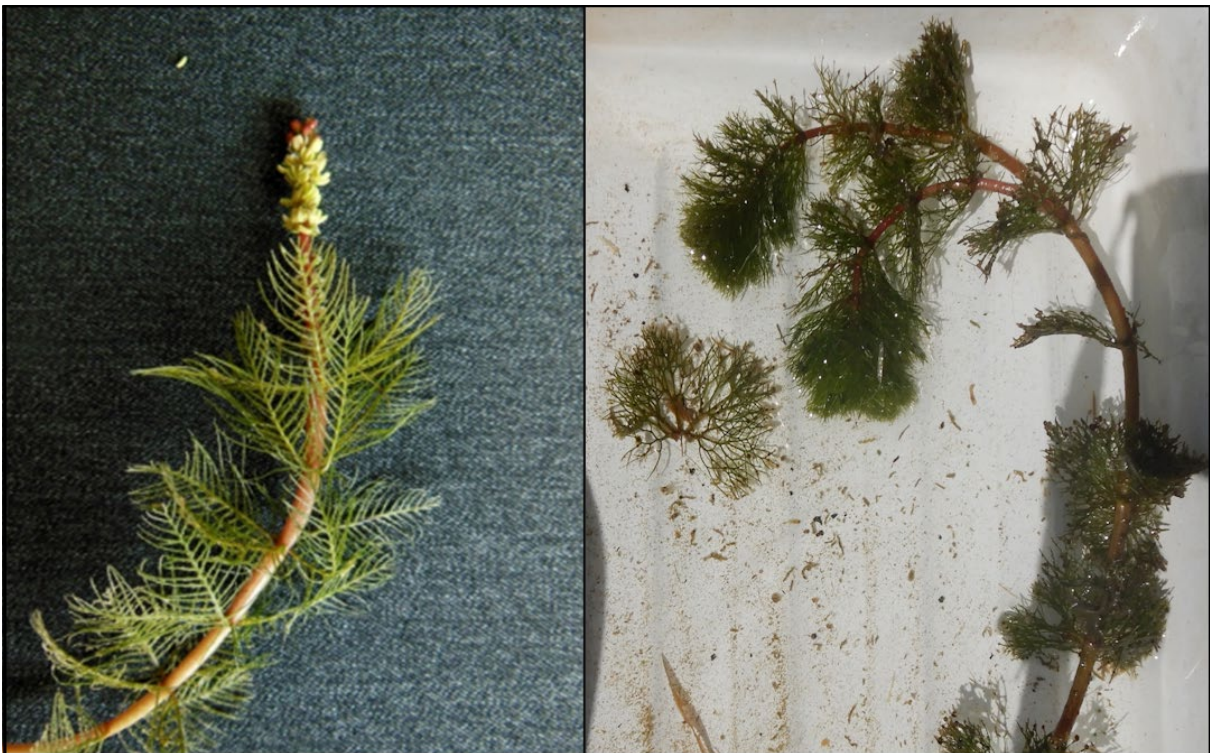
6. ***Eurasian watermilfoil*** (*myriophyllum spicatum*). After careful search under favorable survey conditions, no Eurasian watermilfoil plants were found during the meander search. We documented the water marigold (*Bidens beckii*) on Hagerman Lake. This native species could be mistaken for Eurasian watermilfoil (Photo 5). We greatly encourage lake users to keep an eye open for suspect invasive species. If a questionable species is observed, take photos, record general location or GPS coordinates and provide to White Water. This is important information that could help validate or refute the presence of a new invasive species in the lake. Early detection of non-native invasives increases the likelihood of successful control.

Photo 5. Eurasian watermilfoil (left photo from DEQ 2018 document) and water marigold found in Hagerman Lake (right photo taken August 2024).
